GENERAL ELECTRIC COMPANY

Vallecitos Atomic Laboratory

Ventilation Exhaust Stack (A)

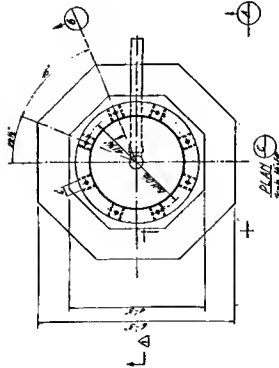
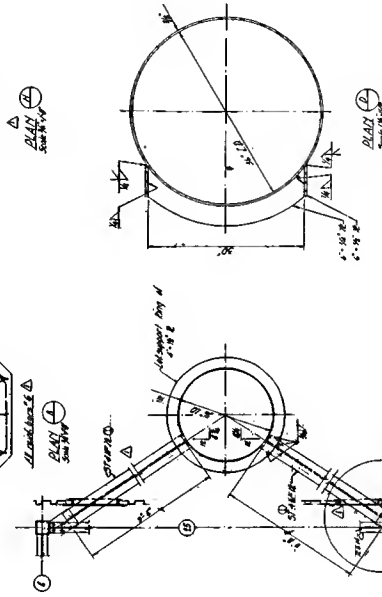
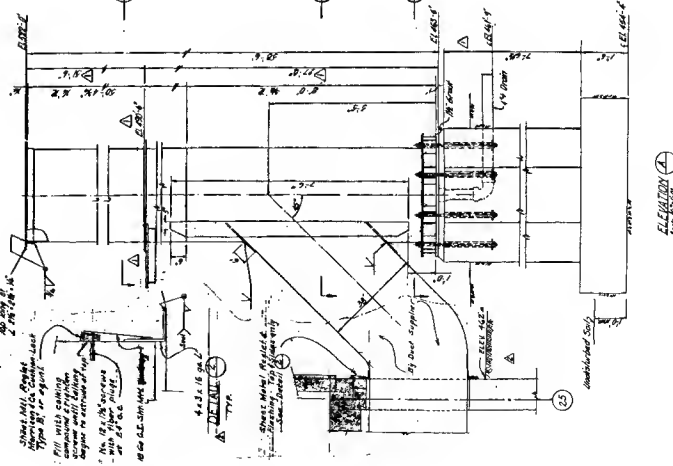
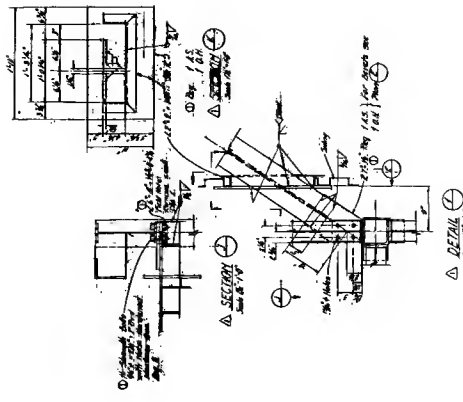
Shortly after work on the extension began in the summer of 1965, a construction engineer on the job reported to Mr. Eagan that the concrete base of the stack was cracked. There were small cracks at each anchor bolt location (Exhibit 1, insert). Each of the four severest cracks ran from an anchor bolt in a roughly vertical path down the base and appeared to continue into the ground.

Mr. Eagan then asked to see the safety engineer's theoretical analysis, which had been done on the basis of static wind loading. Eagan discussed the situation with Brown, and they agreed that wind-induced vibration might have caused the cracks. Brown then remembered seeing an article about wind-induced vibration in tall stacks in "Mechanical Engineering". Since the stack base was internally reinforced with steel rods, they didn't think the base could fail, even if the concrete should crack extensively. They regarded the stack as safe enough to sustain continued operation.

Brown concluded that there might be a possibility of further damage to the stack from wind-induced vibrations and recommended that a guy wire-damper system be installed.

Mr. Eagan decided to have the guy wires installed. He recognized that the cracks could have been caused by any number of circumstances such as a poor concrete mixture or thermal expansion of the anchor bolts. However, Don Brown's analysis seemed to indicate that guy wires should be added and the cost of this was small. Rather than spend more time and money making a detailed analysis of the situation, Mr. Eagan decided to go ahead and have the guy wires installed.
